FORENSIC HUMAN FACTORS ANALYSIS OF SLIP AND FALL INCIDENTS USING A VARIABLE INCIDENCE TRIBOMETER

Terence J Fischer and Jamie S A Fischer

Fischer Forensic Services, LLC Northfield, NJ 08225 USA

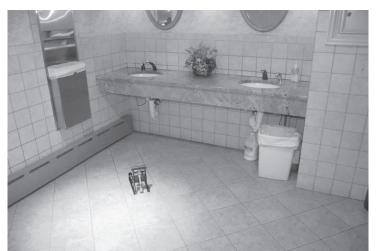
Measurements of the slip resistance of the flooring were taken using the English XL VIT. The testing results indicated that when dry, the tiles had a slip resistance of 0.58, therefore slip resistant. When wetted with local tap water, the slip resistance measured 0.31 and was considered not slip resistant and by code it was classified as hazardous.

Witnesses testified that two other patrons were in the restroom at the time of the incident and had just finished washing their hands. An inspection of the restroom indicated that two sinks were located in the countertop. The restaurant installed a paper towel dispenser on the left side wall approximately 2 feet (0.61 meters) from the left sink. Patrons using the right sink had to walk approximately 6 feet (1.83 meters) to obtain a towel after washing their hands. This resulted in right sink users dripping water on the floor as they walked to retrieve a towel.

The design of the restroom led to the hazardous conditions. The placement if the towel dispenser on the wall opposite the sink caused patrons to drip water onto the floor. Review of ADA standards and reference safety texts identified the unsafe condition caused by the improper design of the subject restroom, specifically the installation of the towel dispenser. The use of flooring that was not slip resistant when wet exacerbated the condition. The behavior by the patrons was not unexpected given the sink placement and general purpose of the room. As indicated by testimony,

Figure 1. Case 1 incident location. Note the distance from the right sink and the towel dispenser at left.
