Investigation Report

Fire in a Petroleum Tank Being Cleaned

Japan National Institute of
JNIOOSH Occupational Safety and Health

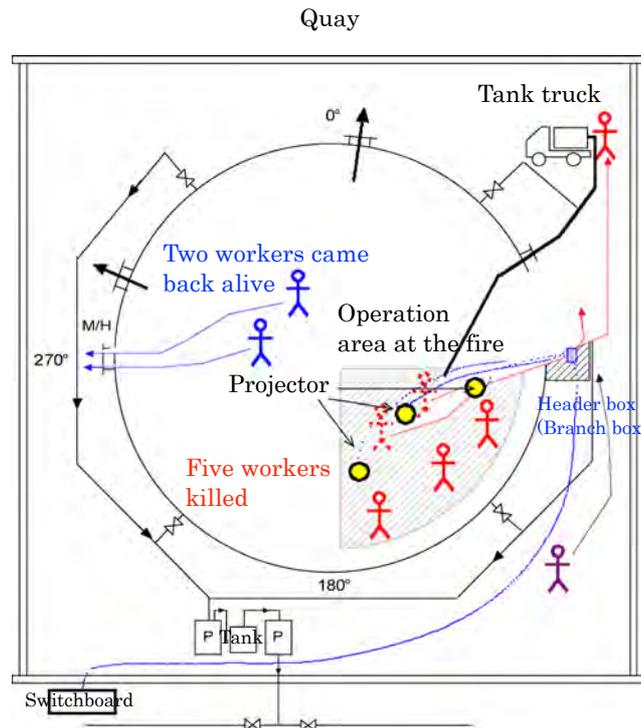
(a) Location of workers when the fire started

Two of the five workers who were killed might have escaped from the tank, but they had whole body burns. The others (three workers) died in the tank because interior metal heating tubes, electrical wiring, and air hoses for gas masks were in the way of their escape.

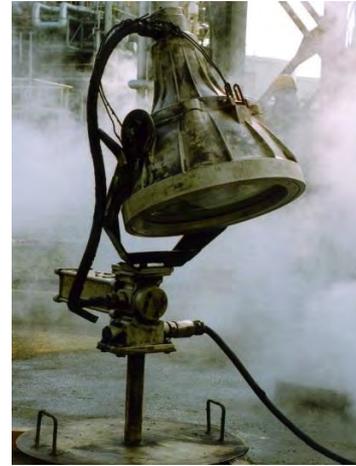
(c) Projector (explosion-proof)

The sludge was softened with solvent oil (light oil or heavy oil A) before cleaning. The combustible vapor from the solvent oil was exhausted from two manholes using explosion-proof electric blowers that were just outside the tank. There is a company (local) rule that workers cannot enter a tank when the concentration of flammable vapors is more than 1,400 ppm (the reference value). At 8:30 am on the day of the disaster, 700 ppm of the concentration was measured near the manhole when the workers entered the tank. It seems that the concentration was not measured again after the first measurement. The explosion-proof projectors were sitting on a temporary table in the tank to light the inside. All workers wore waterproof antistatic raincoats and gas masks with air hoses. The temperature was 10.7°C and the relative humidity was 48%. At the first investigation, it was thought that radiant heat from a light bulb or a spark caused by the fall of the projector were the ignition sources, but there was no proof for this.

- Equipment must not be modified unnecessarily (in particular, any modifications that affect explosion protection are strictly prohibited).
 - Equipment must be installed to prevent objects from falling. (The projectors were not fixed in place. They must be secured to prevent them from falling even if it interferes with work.)

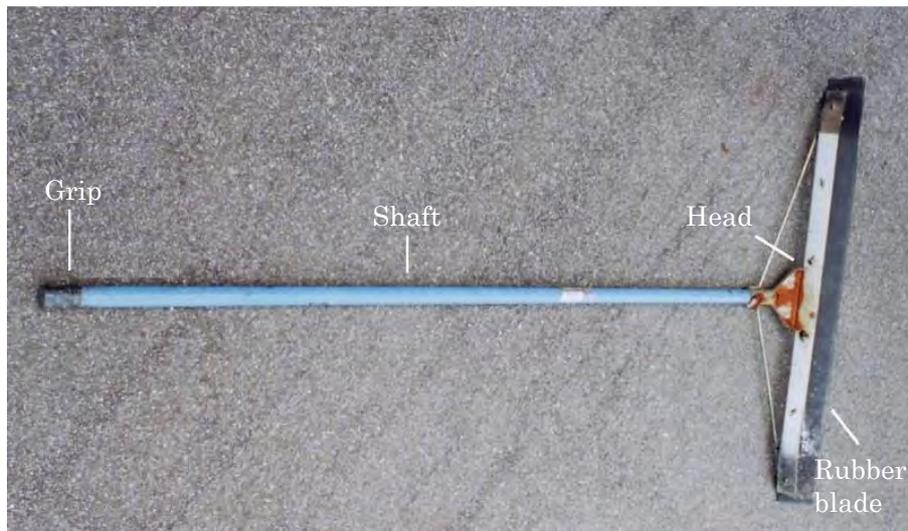
Figure 2. The same type of scraper used

A photograph of the same type of scraper as the ones used at the disaster is shown in Figure 2. The metal shaft of the scraper is coated with polypropylene plastic. Grabbing the shaft with gloves can cause a charge separation between the gloves and the coating (Fig. 3 (a)). Some of the charge remains in the coating after the shaft is released. This residual charge

To prevent a reoccurrence of this kind of disaster, it is important to avoid using cleaning tools that have an insulating coating. In addition, to mitigate potential harm to people, clothing should be flame retardant or incombustible.

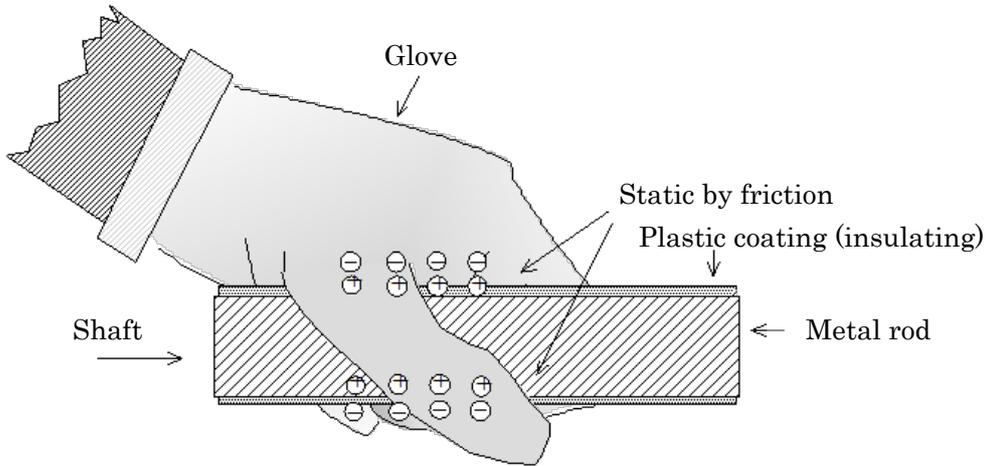
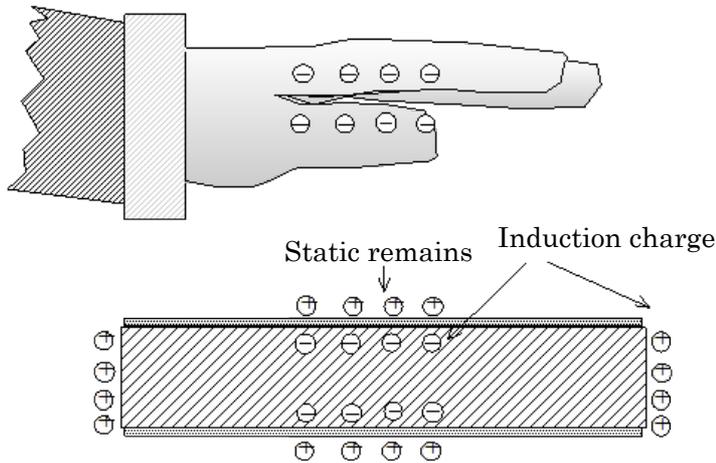
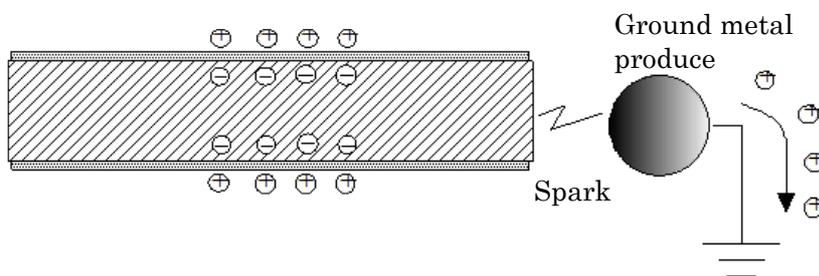
Figure 3. Principle of electrostatic charge on metal parts with an insulating coating (shaft)

causes an induction charge on the metal shaft. The induction charge increases electric potential and distributes a charge on the shaft heterogeneously (Fig. 3 (b)). Moving the scraper close to ground metal produces a spark discharge (Fig. 3 (c)). Charge separation is caused not only by grabbing, but also by the shaft rubbing against an object (clothing, duster, etc.).

(a) Friction between glove and plastic coating causes static.

(b) A static charge remains in the coating on the metal rod after the shaft is released (induction charge).

(c) Moving the rod close to ground metal produces a spark discharge.

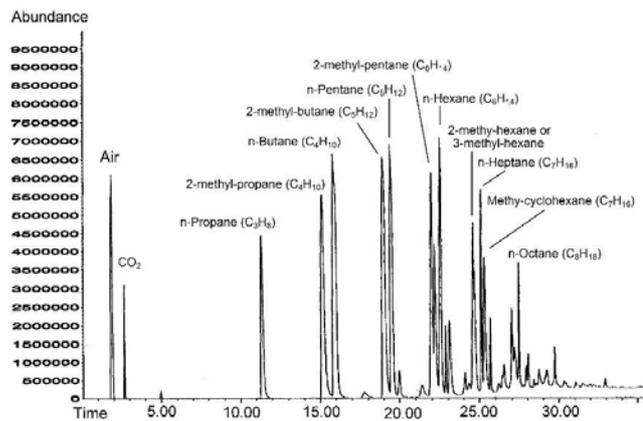
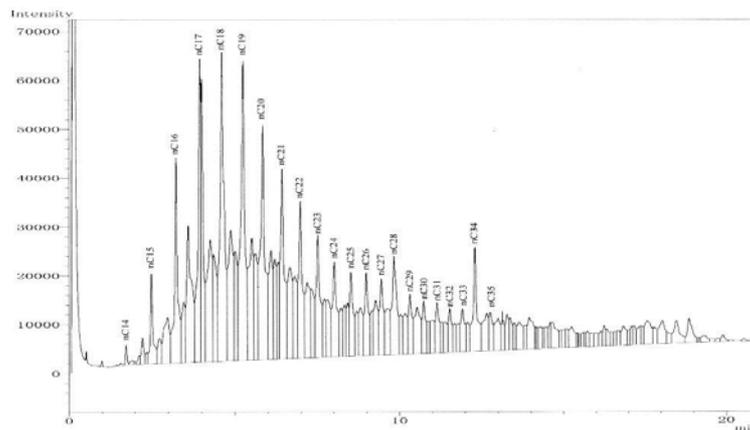
Figure 4. Composition of sludge

sludge and then wiping this off with a cloth. The results of our analysis are shown in Figures 4 (a) and (b). These results show that the hydrocarbons (up to C8) are volatilized from the sludge, and that this formed an explosive atmosphere with the ignition energy (0.8 mJ) at the same temperature as that during the disaster. Also, the existence of petroleum wax (C14 ~ C35) on the shaft was suggested.

Incidentally, industrially purified petroleum wax is used as an electrical insulating material due to its very high resistivity: $10^{13} \sim 10^{17} \Omega\text{m}$.

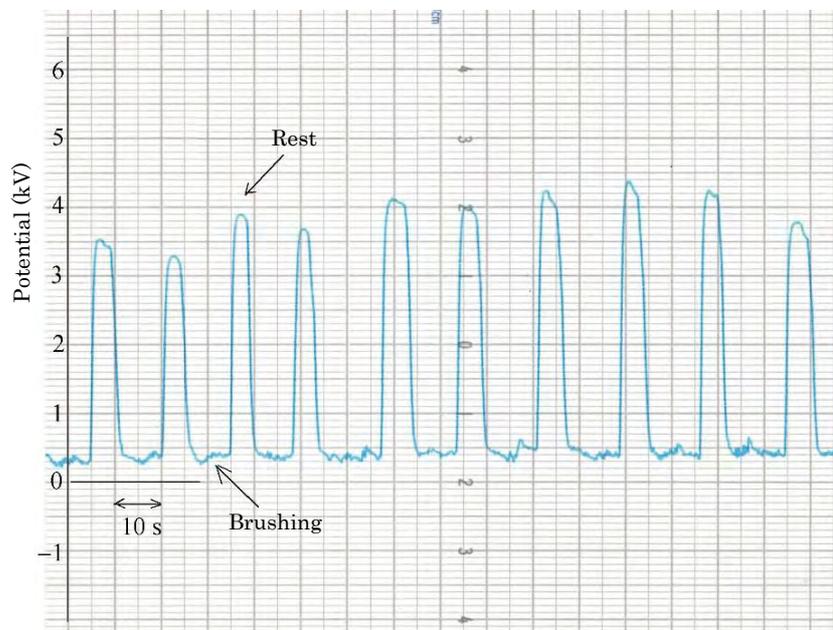
Figure 7. Potential change of the scraper during scraping

A typical example of the potential change is shown in Figure 7. During scraping, the potential barely increased, but the potential did rise the moment there was pause in scraping and the scraper was released from one hand. As discussed in Section 2, an electrostatic charge was generated between the gloves and the coating on the scraper's shaft, and an electrostatic induction occurred in the metal rod of the shaft from the charge remaining in the coating when it was released. Charge relaxation was slow because the resistance of the rubber is high.

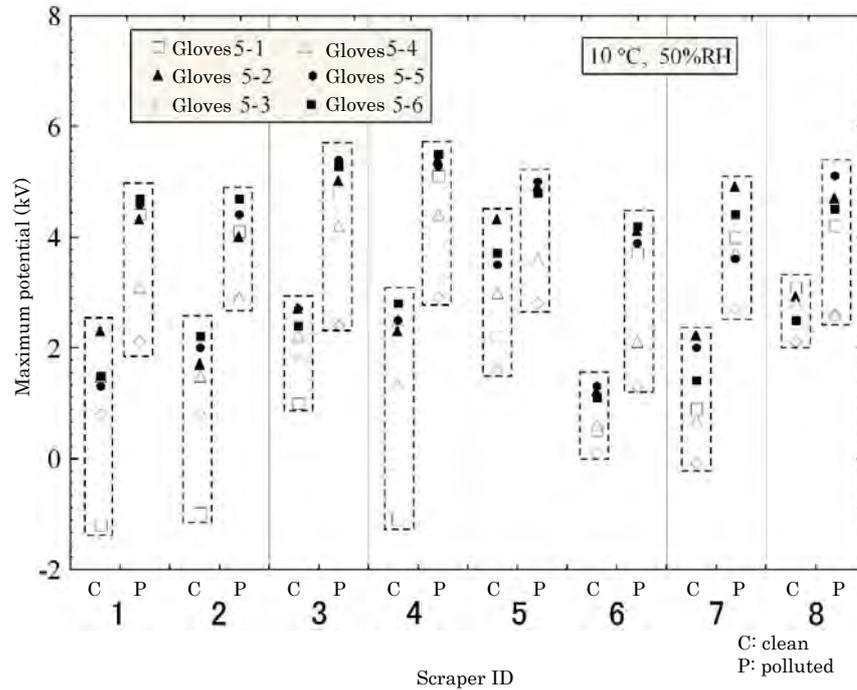
Figure 8. Difference in potential between "clean" and "polluted" shafts

A plot of the maximum value of the potential obtained in each combination is shown in Figure 8. Items 6 and 7 are used scrapers. Figure 8 shows clearly that a "polluted" scraper had much higher potential than a

"clean" one. This was an effect from the petroleum wax components. The surface resistivity increase from the wax was a factor in the difference in the potential (as described above).

The charge generated was 0.26~0.36 μC . The electrostatic energy was 0.51~0.91 mJ. These values were calculated from the capacitance 52~70 pF of the scraper at rest (Fig. 5 (b)) and the maximum potential 4.7 ~ 5.5kV obtained for the "polluted" scraper. Based on the supposition that the effective contact area between the shaft and the gloves was 100 cm^2 , the average surface charge density was estimated to be 36 $\mu\text{C}/\text{m}^2$ at the maximum. In theory, the charge density of the conductor surface is 27 $\mu\text{C}/\text{m}^2$ at the maximum because it is limited by discharge into the air. (The dielectric breakdown field of air is 3 MV/m.) However, in this case, thin insulation on the surface of the metal rod suppressed the potential and the electric field at the surface of the insulating layer. This can cause higher surface charge density.

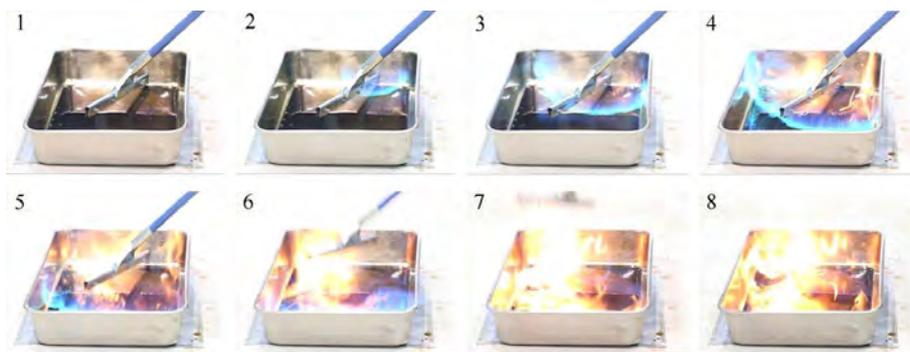
Figure 9. Ignition of petroleum with charged scraper

Scrapers with charging potentials of 5 kV, 6 kV, 6.5 kV and 7 kV were tested for their ability to cause an ignition. The potential of 5 kV or 6 kV could not ignite petroleum. The potential of 6.5 kV and 7 kV ignited and

caused the petroleum to burst into flames, as shown in Figure 9. Discharge energy at ignition was estimated to be 1.3 mJ and 1.5 mJ, respectively. These values were slightly higher than the minimum ignition energy (0.8 mJ) shown in Section 3.1. The reason for this difference could be the instability of vapor concentrations in an open space. In Section 4.1, the maximum electrostatic energy obtained by simulating the operation was 0.91 mJ, which is higher than the minimum ignition energy (0.8 mJ).

It is notable that in the testimony (see Section 1) of a survivor he said, "A pale blue flame began to spread rapidly." In this test, after ignition a pale blue flame on the liquid surface was observed. During cleaning in the tank there would have been a flammable premixed gas on the sludge surface.

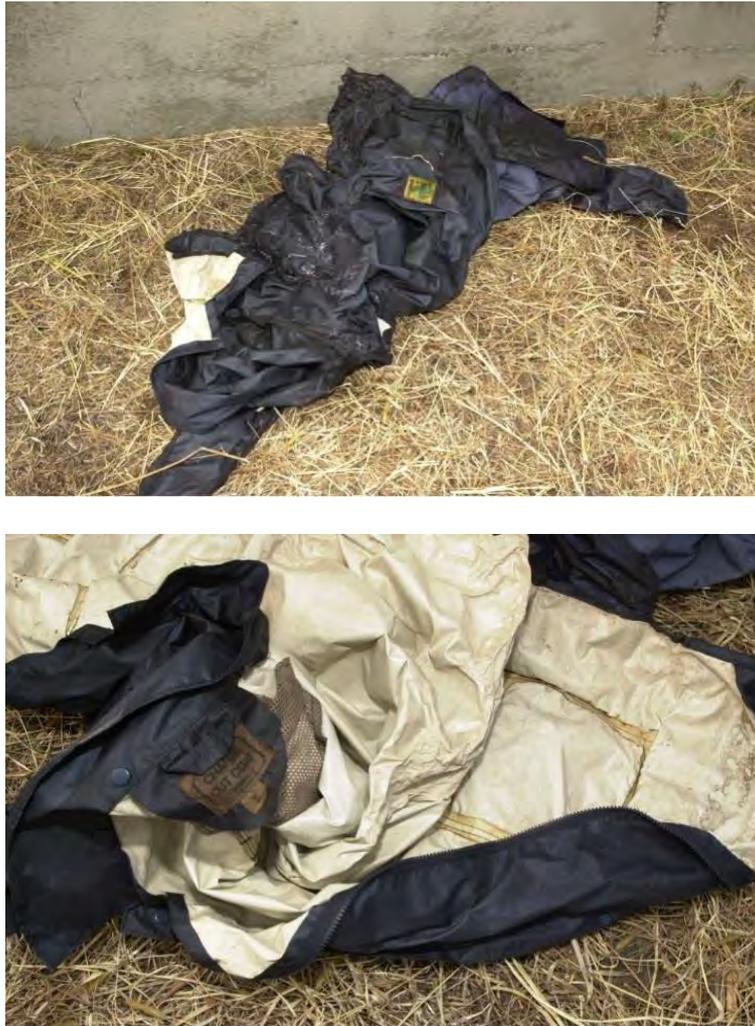
Figure 10. Raincoats that the victims wore (antistatic)

The number of people killed in this disaster (five) is high. Two of those killed could have escaped from the tank but all of their clothing was burned and they were almost naked when they were found. One of the raincoats of the victims is shown in Figure 10. The victims wore these raincoats over their work clothes (cotton coveralls). Their clothing was considered to be both antistatic and nonpolluting. Sample pieces (320 mm × 50 mm) of these clothes were tested by the A-4 method for the combustibility of fiber products (JIS L 1091). The results of the test showed that they were "guttled" within

10 seconds. Therefore these clothes were highly flammable. Their characteristics made these clothes easy to burn and caused the spread of damage in this disaster. To prevent a reoccurrence of this disaster, antistatic coveralls should be incombustible or flame retardant where there is a risk of fire.
