Investigation Report

An explosion accident during tank
repair at a chemical plant

National Institute of Occupational Safety

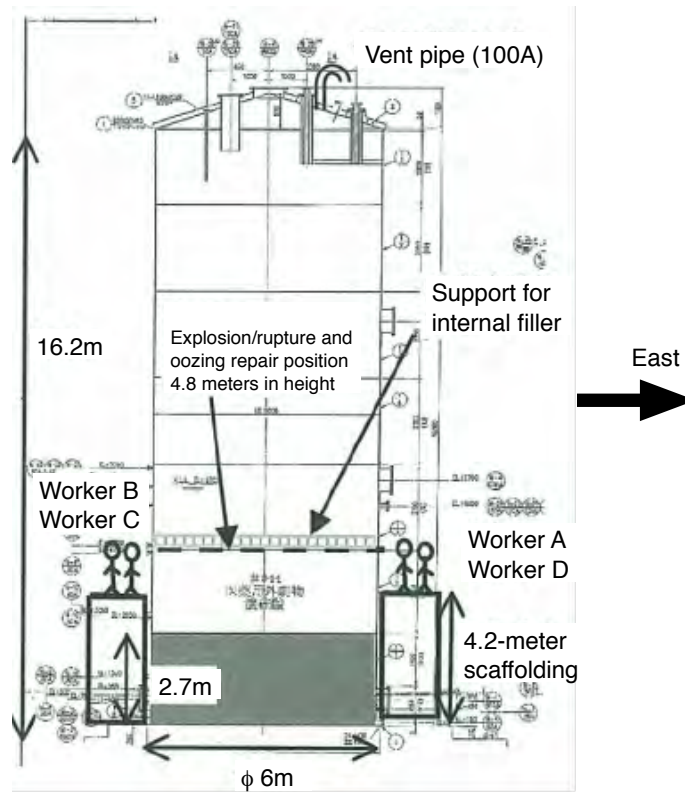
Figure 5: Schematic drawing of 044 Tank (Workers' location at the accident)

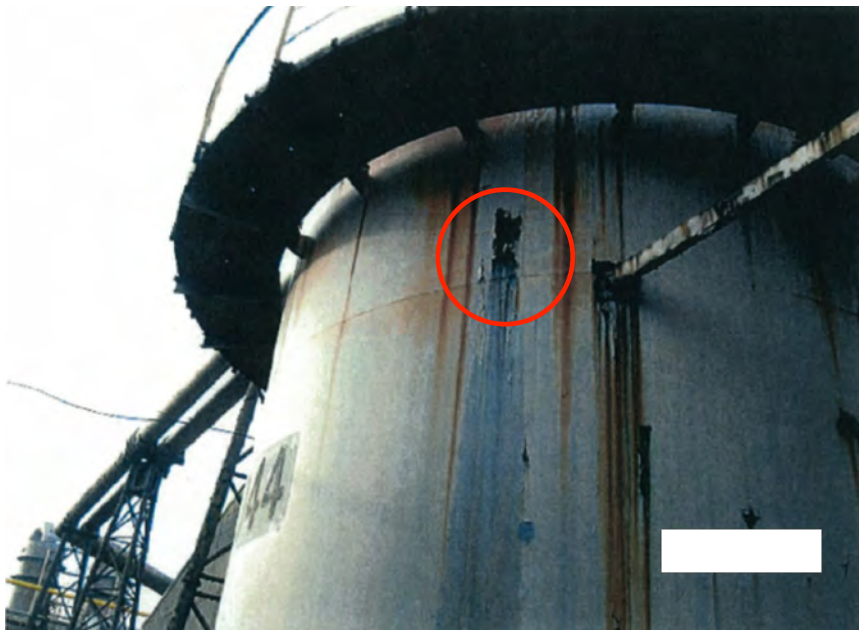
- (1) Four days before the accident, signs of oozing were detected at two places by visual observation (Figure 6). Oozing seemed to be occurring at a height of five meters just around the liquid level. To prevent concentrated sulfuric acid from leaking, concentrated sulfuric acid in the tank was discharged and its liquid level was lowered.
- (2) At 8:40 on the day of the accident, arrangements for work were made and fire prevention measures were taken.
- (3) At 9:20 on the same day, work started.
- (4) At 9:45 on the same day, gas-detecting operation was performed at the external parts of

Figure 6: Oozing observed before the accident

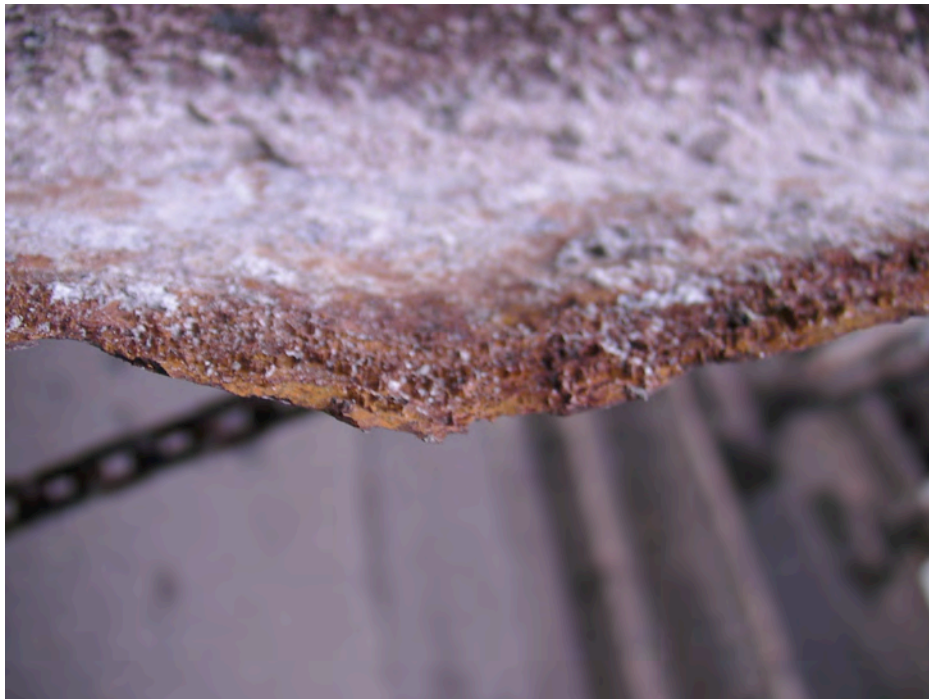
Figure 8: Ruptured part showing apparent thinning

One explosion in a sealed container can generate the absolute pressure of about 400 kPa; the tank is destroyed unless it was specially designed to withstand high pressure. In this accident, pronounced thinning was observed at the part where the layer of dilute sulfuric acid is considered to have formed, indicating reduced strength. Actually, the rupture occurred at that particular part.
