Investigation Report

Fire in a Petroleum Tank Being Cleaned

Japan National Institute of
JNIOOSH Occupational Safety and Health

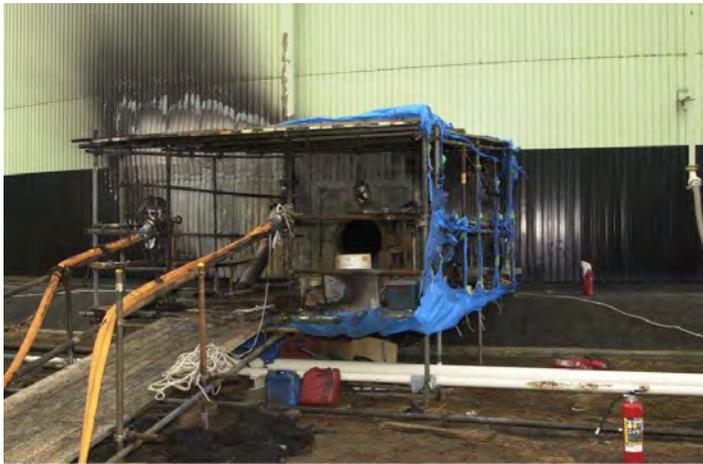
(b) Tank manhole

Two of the five workers who were killed might have escaped from the tank, but they had whole body burns. The others (three workers) died in the tank because interior metal heating tubes, electrical wiring, and air hoses for gas masks were in the way of their escape.

The sludge was softened with solvent oil (light oil or heavy oil A) before cleaning. The combustible vapor from the solvent oil was exhausted from two manholes using explosion-proof electric blowers that were just outside the tank. There is a company (local) rule that workers cannot enter a tank when the concentration of flammable vapors is more than 1,400 ppm (the reference value). At 8:30 am on the day of the disaster, 700 ppm of the concentration was measured near the manhole when the workers entered the tank. It seems that the concentration was not measured again after the first measurement. The explosion-proof projectors were sitting on a temporary table in the tank to light the inside. All workers wore waterproof antistatic raincoats and gas masks with air hoses. The temperature was 10.7°C and the relative humidity was 48%. At the first investigation, it was thought that radiant heat from a light bulb or a spark caused by the fall of the projector were the ignition sources, but there was no proof for this.

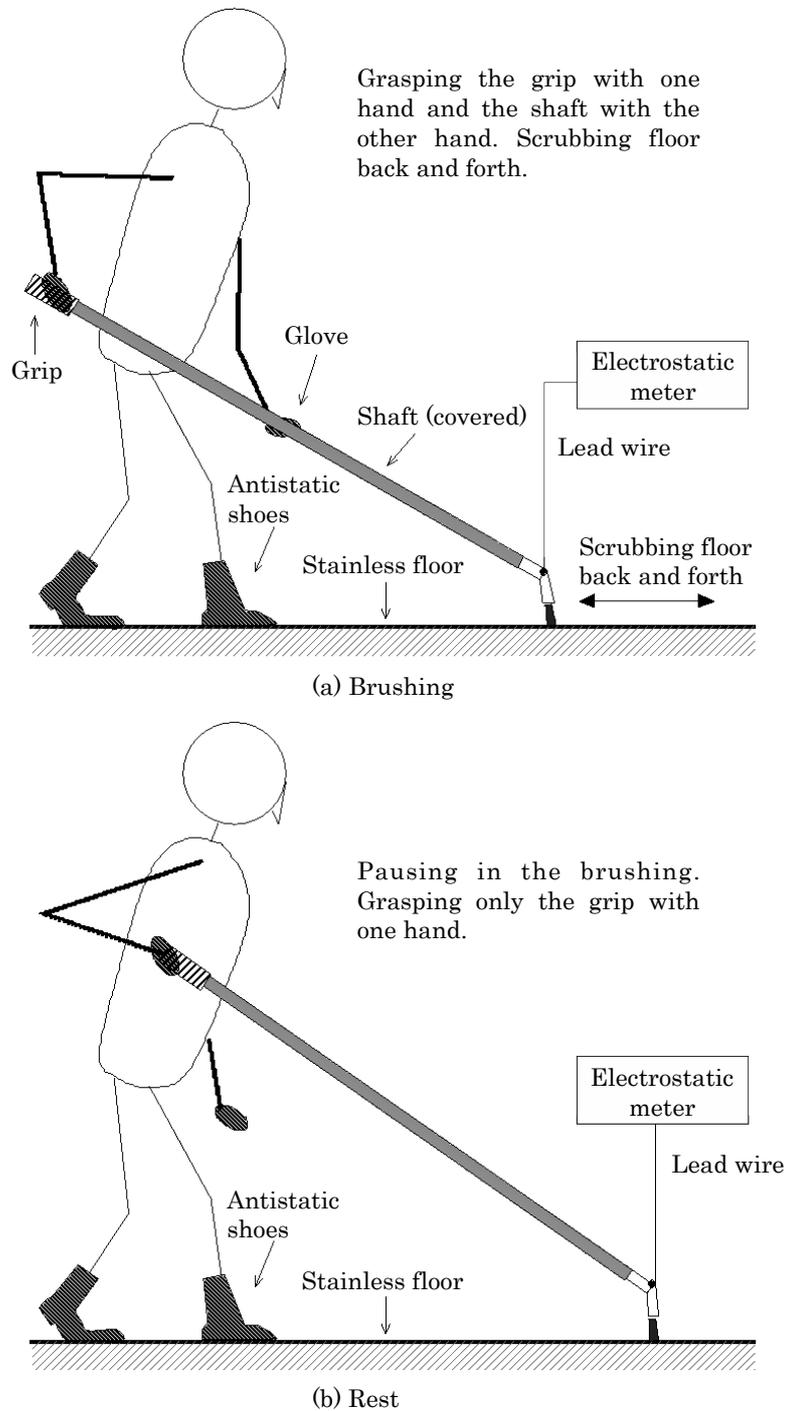
Figure 5. Experiment to determine static electricity generated during scraping

Based on interviews with workers, the work using these scrapers was reproduced and the potential of the metal shaft of the scraper was measured. For scraping, brushing (Figure 5(a)) motions and rest (Figure 5(b)) were repeated alternately. To reproduce the atmosphere at the time of the disaster, experiments were conducted at 10°C with a relative humidity (RH) of 50%.

The charge generated was 0.26~0.36 μC . The electrostatic energy was 0.51~0.91 mJ. These values were calculated from the capacitance 52~70 pF of the scraper at rest (Fig. 5 (b)) and the maximum potential 4.7 ~ 5.5kV obtained for the "polluted" scraper. Based on the supposition that the effective contact area between the shaft and the gloves was 100 cm^2 , the average surface charge density was estimated to be 36 $\mu\text{C}/\text{m}^2$ at the maximum. In theory, the charge density of the conductor surface is 27 $\mu\text{C}/\text{m}^2$ at the maximum because it is limited by discharge into the air. (The dielectric breakdown field of air is 3 MV/m.) However, in this case, thin insulation on the surface of the metal rod suppressed the potential and the electric field at the surface of the insulating layer. This can cause higher surface charge density.

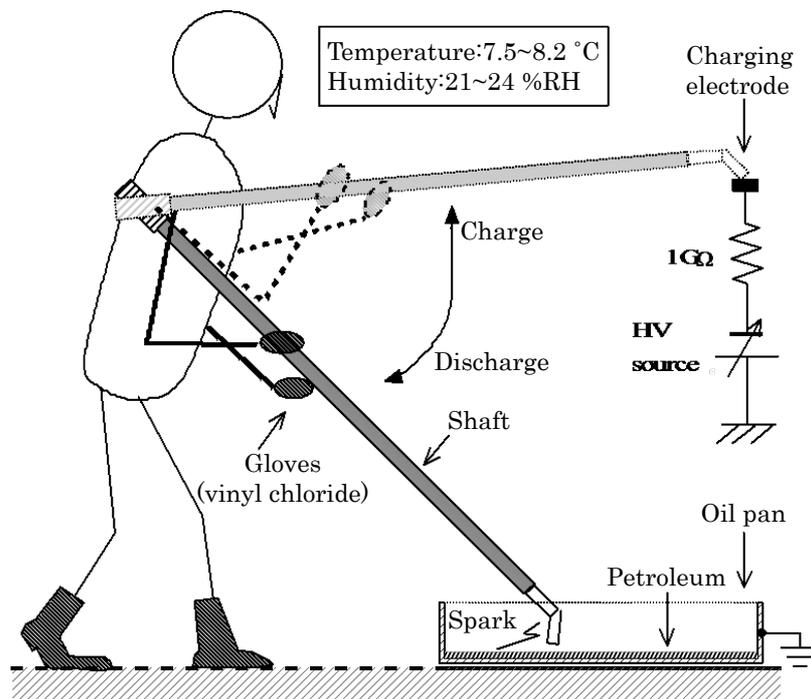
Figure 6. Ignition test of petroleum with charged scraper

The ability of a spark to cause an ignition near petroleum was examined (Figure 6). Petroleum was poured into a metal pan (60 cm × 40 cm × 10 cm). A scraper was charged from a DC high voltage power source. A spark was created on the inner wall of the oil pan near the liquid surface. This experiment was carried out at 8.2°C at 21% relative humidity (RH).
