Investigation Report

An explosion accident during tank
repair at a chemical plant

National Institute of Occupational Safety

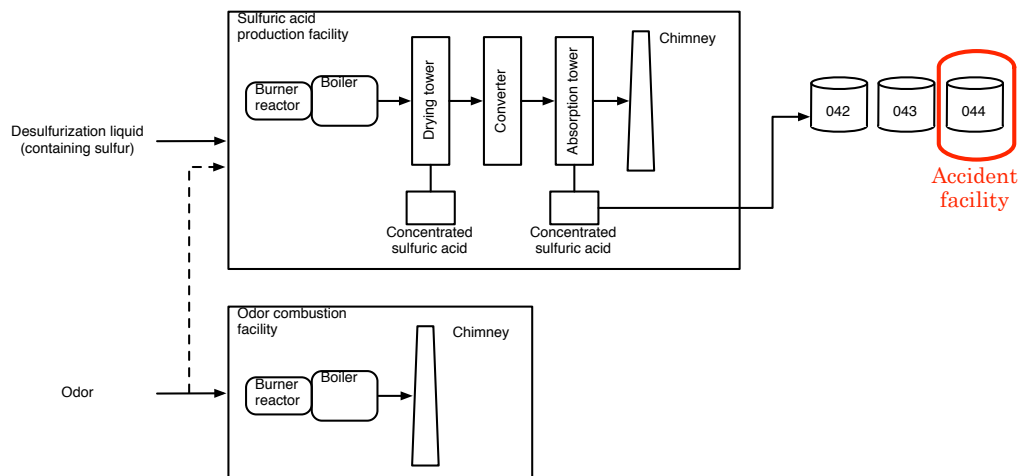
Figure 3: Flow diagram of the sulfuric acid facility in C gas purification (during normal operation)

The facility that caused the accident is mainly used to obtain high-purity sulfuric acid by burning desulfurization liquid coming from the desulfurization facility but sometimes also used to remove odors of exhaust gas and other substances as shown in Figure 3. There is another odor treatment facility, but the investigation found that this odor treatment facility had been undergoing the annual inspection since one week before the accident, and thus the facility that caused the accident was used as an alternative to the odor treatment facility. During that period, the facility only treated odor, which accordingly did not make sulfuric acid obtained at the drying tower sufficiently concentrated. As a result, sulfuric acid that was more dilute than usual was transferred to the 044 tank on November 26. This is the primary cause of the accident.
