# Exposure to Human Waste from Spills while Servicing Aircraft Lavatories: Hazards and Methods of Prevention

**Abstract:** Workers service the lavatories of commercial aircraft approximately 11 million times per year in the United States and may have exposure to the spectrum of pathogenic viruses, bacteria and parasites potentially found in human waste. An industrial hygiene walk-through of the workplace was conducted by an interdisciplinary occupational health and safety team, and lavatory waste operators and supervisors and the process was observed. Exposure to untreated waste can occur through dermal, ingestion, and inhalation in quantities ranging from droplets to large spills. Several engineering and administrative measures were advised to minimize worker exposure, including the effective locking of a critical valve, and a mechanism for communicating valve locking problems.

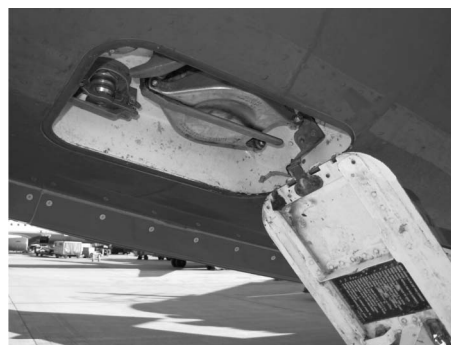
Fig. 1. Access panel to aircraft waste port.

The waste removal process begins when the operator approaches the aircraft in a powered industrial vehicle (PIV) equipped with the removal apparatus (hose, pump, and holding tank), and parks the PIV a few meters from the aircraft. The operator then opens a waste service panel on the fuselage (Fig. 1), and uses a handle to open the waste port covering (Fig. 2). A hose from the removal apparatus is attached to the waste port on the aircraft, and is secured with a threaded fastener (Fig. 3). The operator then initiates waste flow by pulling a t-shaped handle (Fig. 2) that opens a flap in the toilet to open the system to assist in flow of the waste. Next a toggle is activated (Fig. 2) which opens a valve (Figs. 4a–c) at the waste port on the aircraft to permit waste flow into the attached hose; a mechanical pump assists in the removal. The

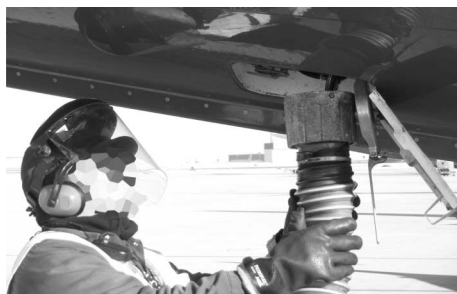
Fig. 3. Operator connecting hose from waste removal vehicle to aircraft waste port.

operator aids the pumping action by periodically lifting the hose so waste continues to flow into the vehicle holding tank. When all of the waste has been removed, the operator pushes the t-handle in to close off the flap in the toilet. The threaded fastener that secures the hose to the waste port is released by turning counterclockwise. The operator then wipes, as necessary, the inner diameter of the waste port and wipes off the valve area to ensure there is no waste that would prohibit a proper seal and closure. Finally the handle is used to simultaneously close the valve on the waste port and the waste port cover (Figs. 4a–c). For certain aircraft models, a supply hose is attached to a separate port to re-fill the lavatory deodorizing fluid used to flush the toilet; other models use the potable water system, which is loaded onto the aircraft at a different location. The waste service panel on the fuselage is then closed and service is complete. The entire service process takes three to seven minutes. In the course of observing lavatory service on several aircraft, it was clear that droplet splashes occur downwind of the waste port valve when it is opened. The exact number and locations of the panels varies across specific aircraft models.
